BALRANALD MINERAL SANDS MINE

2025 ANNUAL REVIEW

(1 January 2025 to 31 December 2025)

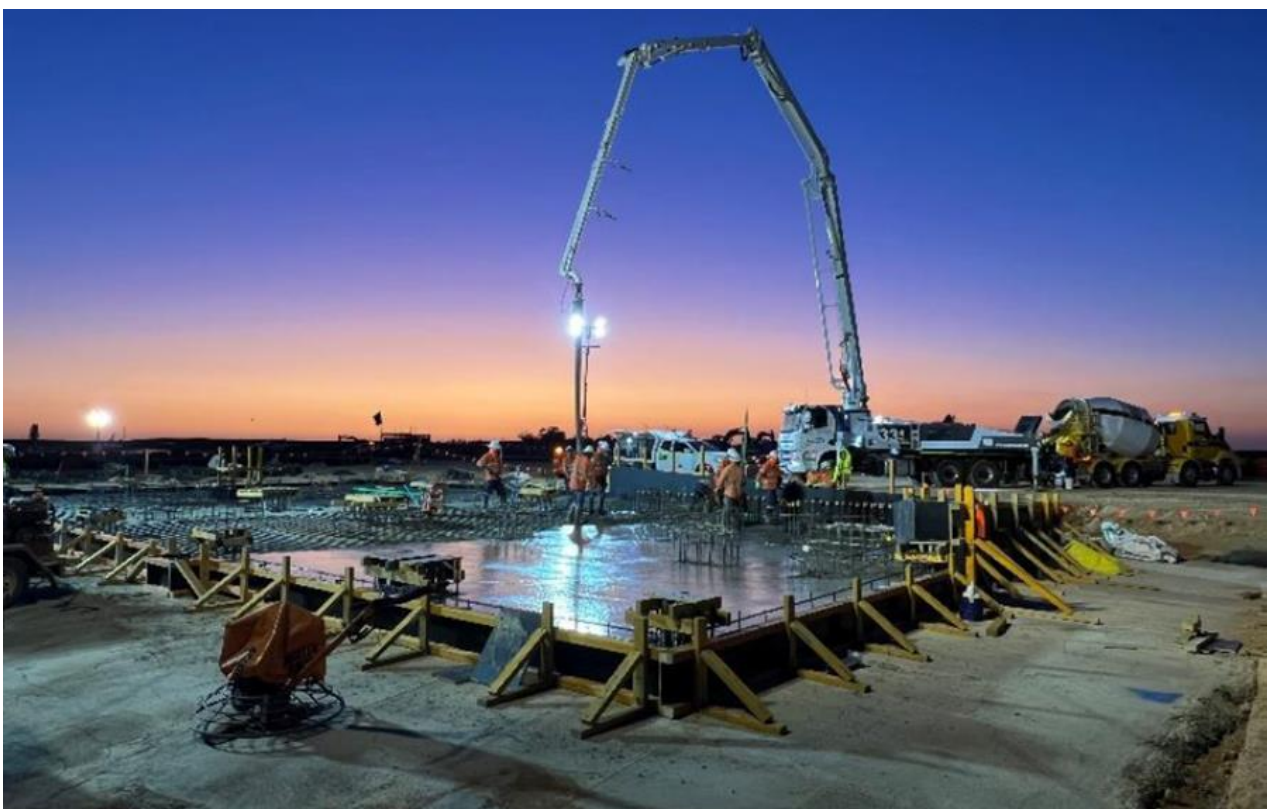
Photo 1: Construction of stacker pad area in early 2025.

Photos 1 and 2 represent ongoing construction during the reporting period 2025.

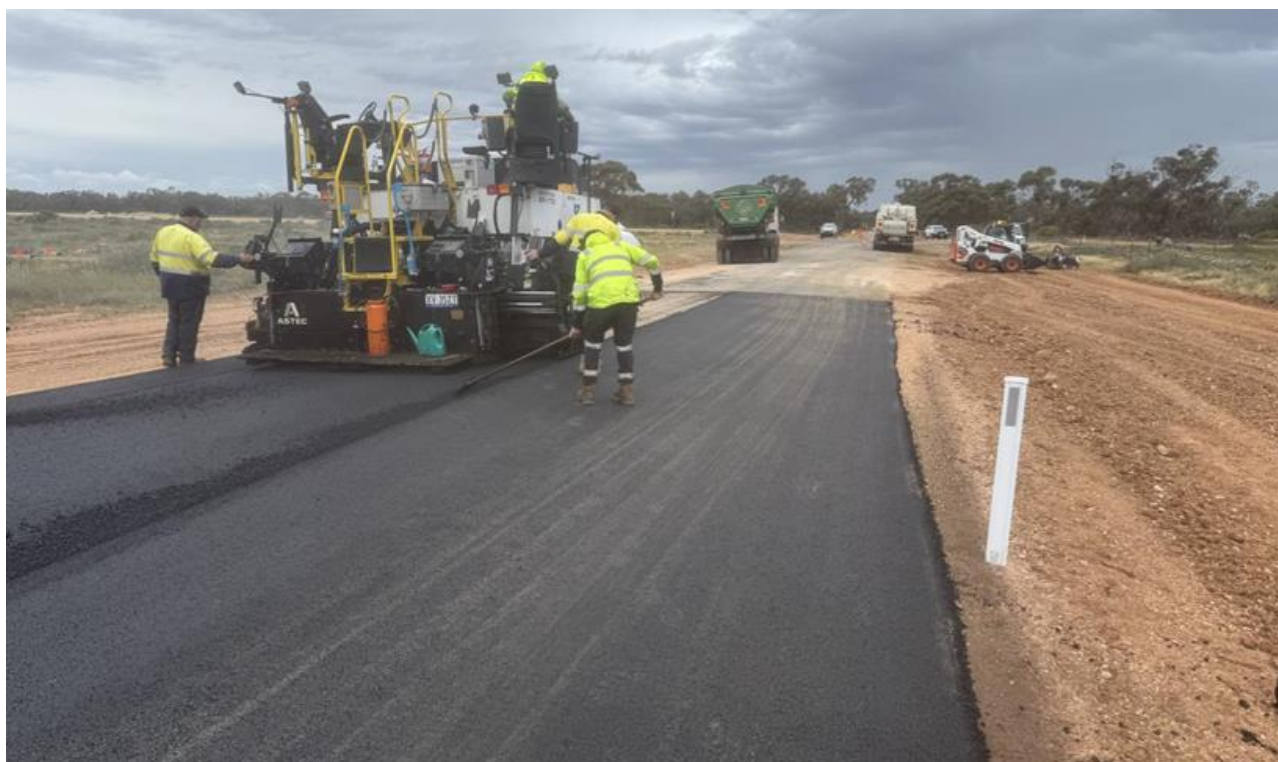
Photo 2: Public road upgrade and widening works of McCabe Street and Balranald-Ivanhoe Road intersection completed in September 2025.

Public road upgrades that were completed during the 2025 reporting period in compliance with the consent (Condition 22 of Schedule 3) in consultation with the applicable road authorities are:

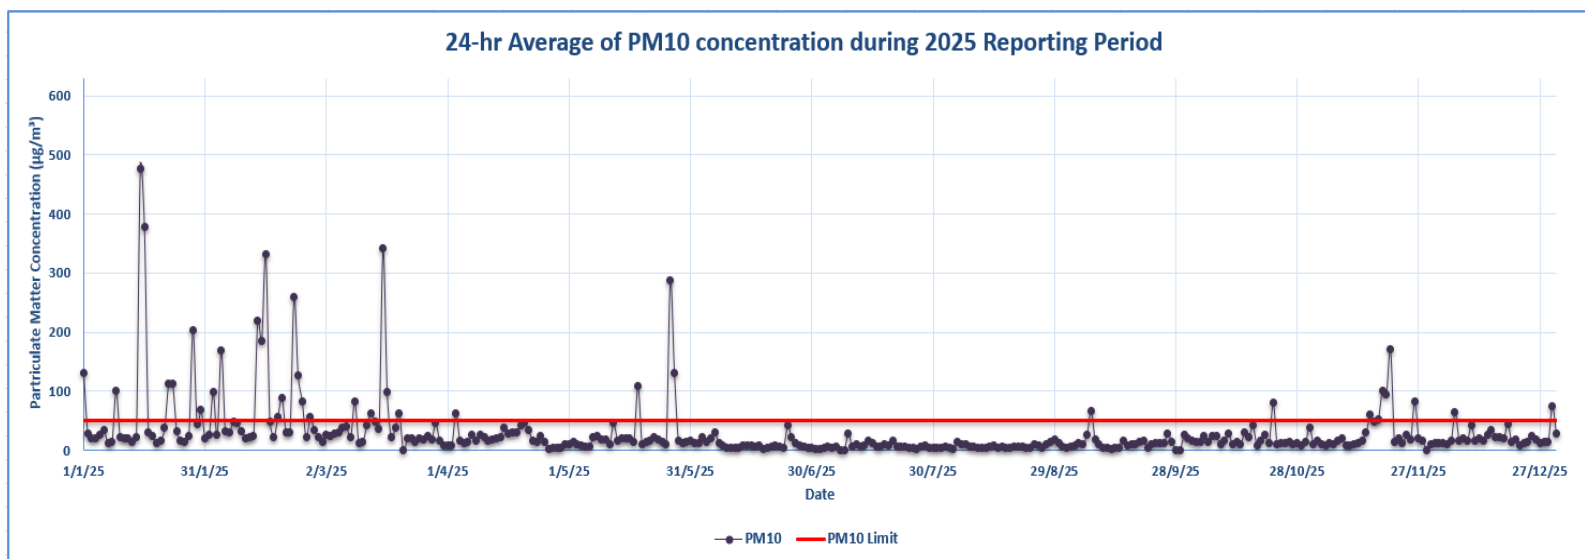
Figure 3 The 24 hour average of PM10 concentration at CPM1 during 2025 reporting period

Short term impact assessment of particulate monitoring indicate 38 exceedances in PM10 criteria and 11 exceedances in PM2.5 criteria during 2025 reporting period (refer to Figure 3 and 4). Subsequent investigations confirmed that none of these exceedance were attributable to onsite activities as the prevailing wind direction during those events was not blowing from the site.

In majority of cases, elevated particulate concentrations were addressed as being caused by dry, unconsolidated soils from the adjacent paddocks, which contributed to increased dust levels at the monitoring station. Additionally, bushfire in Grampians was identified as a contributing factor to elevated particulate levels at the monitor in the month of January.

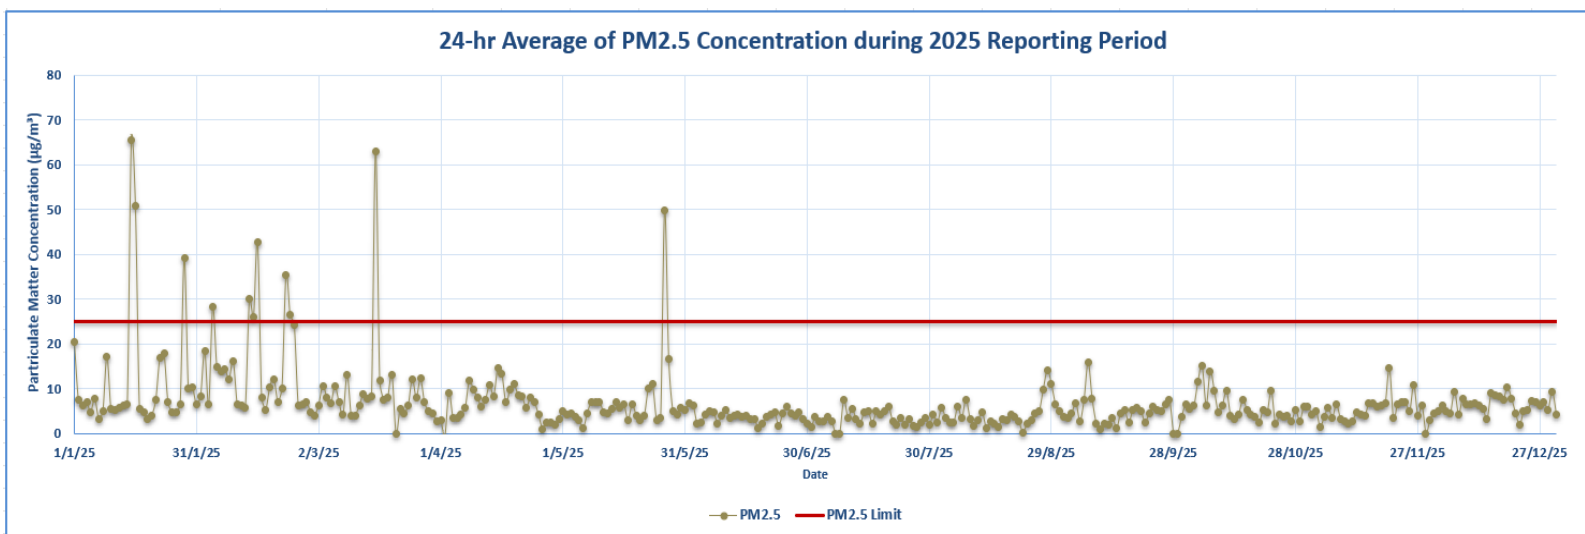
Figure 4: The 24 hour average of PM2.5 concentration at CPM1 during 2025 reporting period

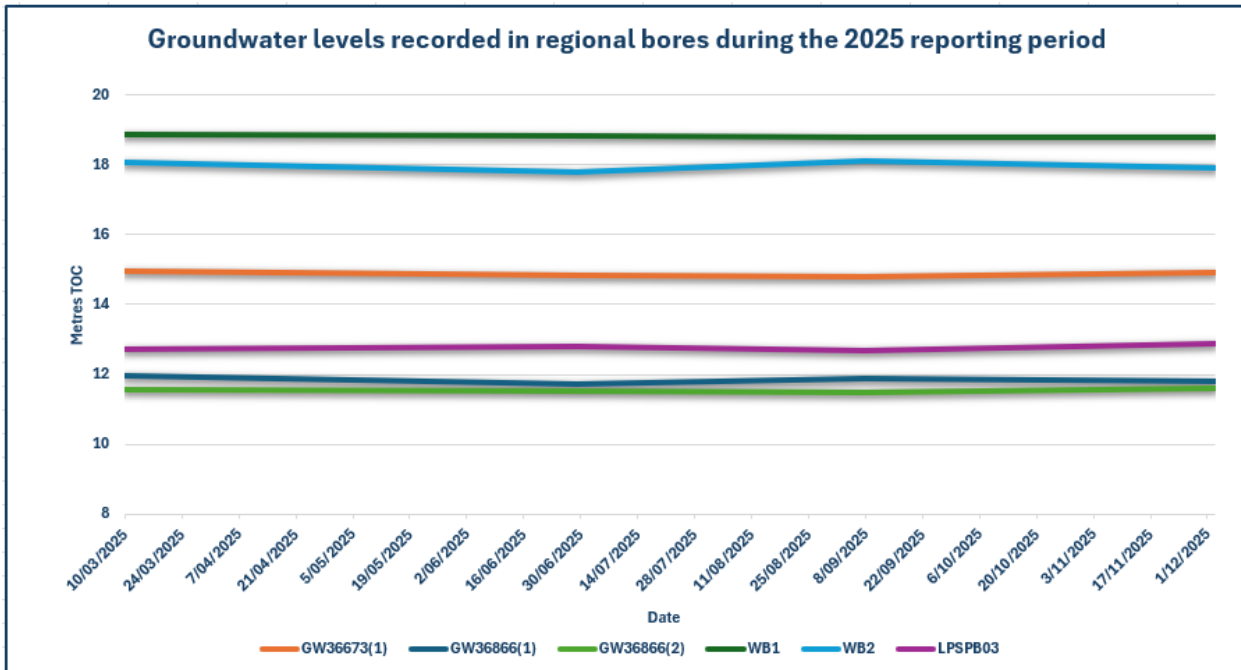
Figure 5: Quarterly groundwater levels for regional bores

Regional groundwater levels showed minor variation throughout 2025, with most bores exhibiting slight decrease in groundwater depth (0.06 - 0.16 m) between Q1 and Q4, indicating a gradual rise in water levels over the year. The exception was LPSPB03, which recorded an increase in groundwater depth of approximately 0.19 m, indicating gradual decline in water level at this location. One bore (GW036866(2)) remained effectively stable, with total variation of only 0.10 m across all quarters. A graph of the quarterly regional groundwater levels is shown in Figure 5.

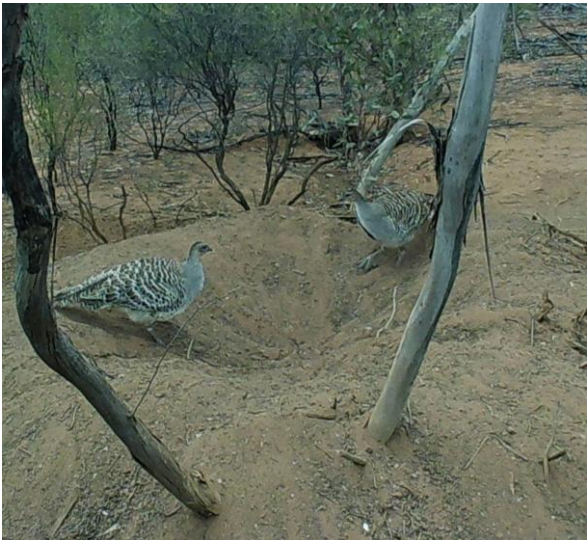
A photograph showing two malleefowl on a sand mound in a mallee woodland. The birds are facing each other, and the ground is sandy with sparse vegetation.
<p>Mound 51</p>

A photograph showing two malleefowl on a sand mound in a mallee woodland. The birds are facing each other, and the ground is sandy with sparse vegetation.
