## **Performance Review Report**

**June 2011 to June 2013**

**Iluka Resources Limited**

**Tutunup South**

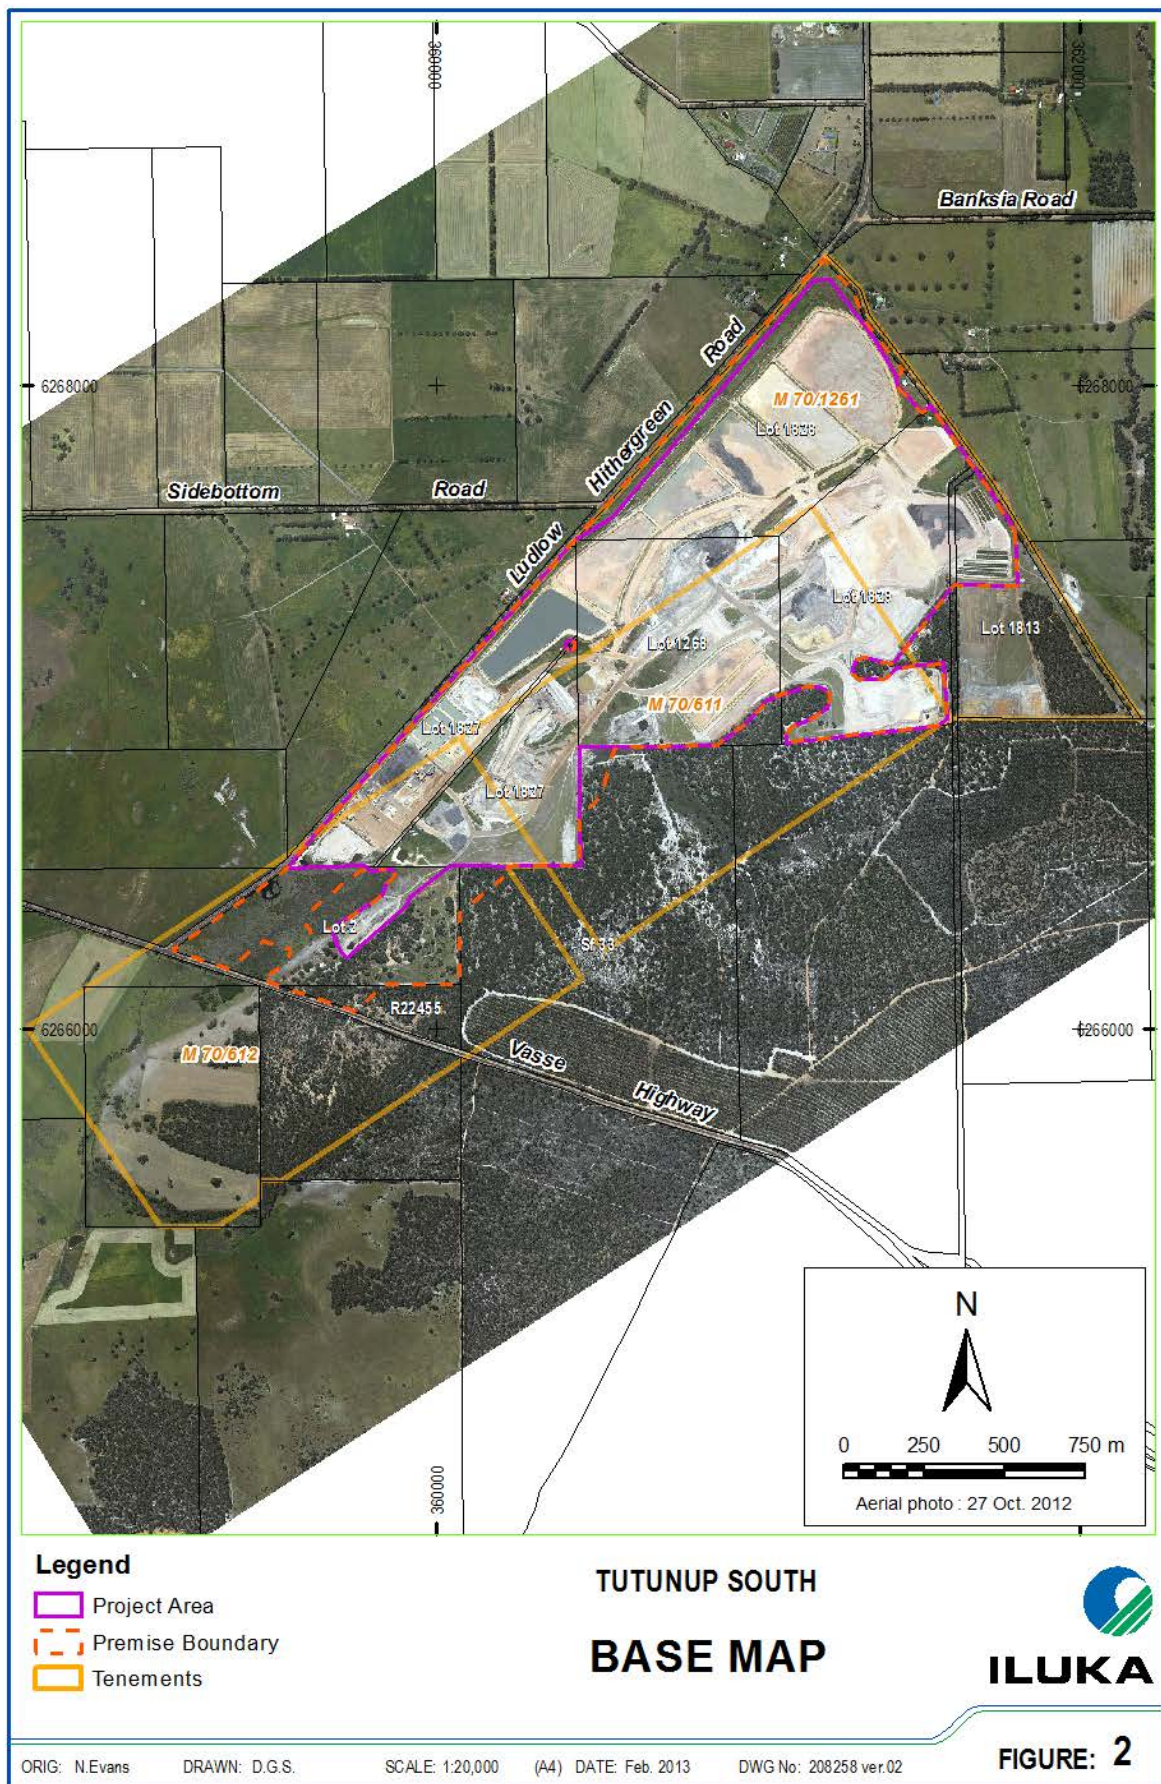
Figure 2. Tutunup South Site Plan

Iluka operates the Tutunup South Mine located approximately 195 kilometres south of Perth and 15 km southeast of the township of Busselton (Figure 1). The project area includes mining tenements, M70/611, M70/612 and M70/1261 (Figure 2).

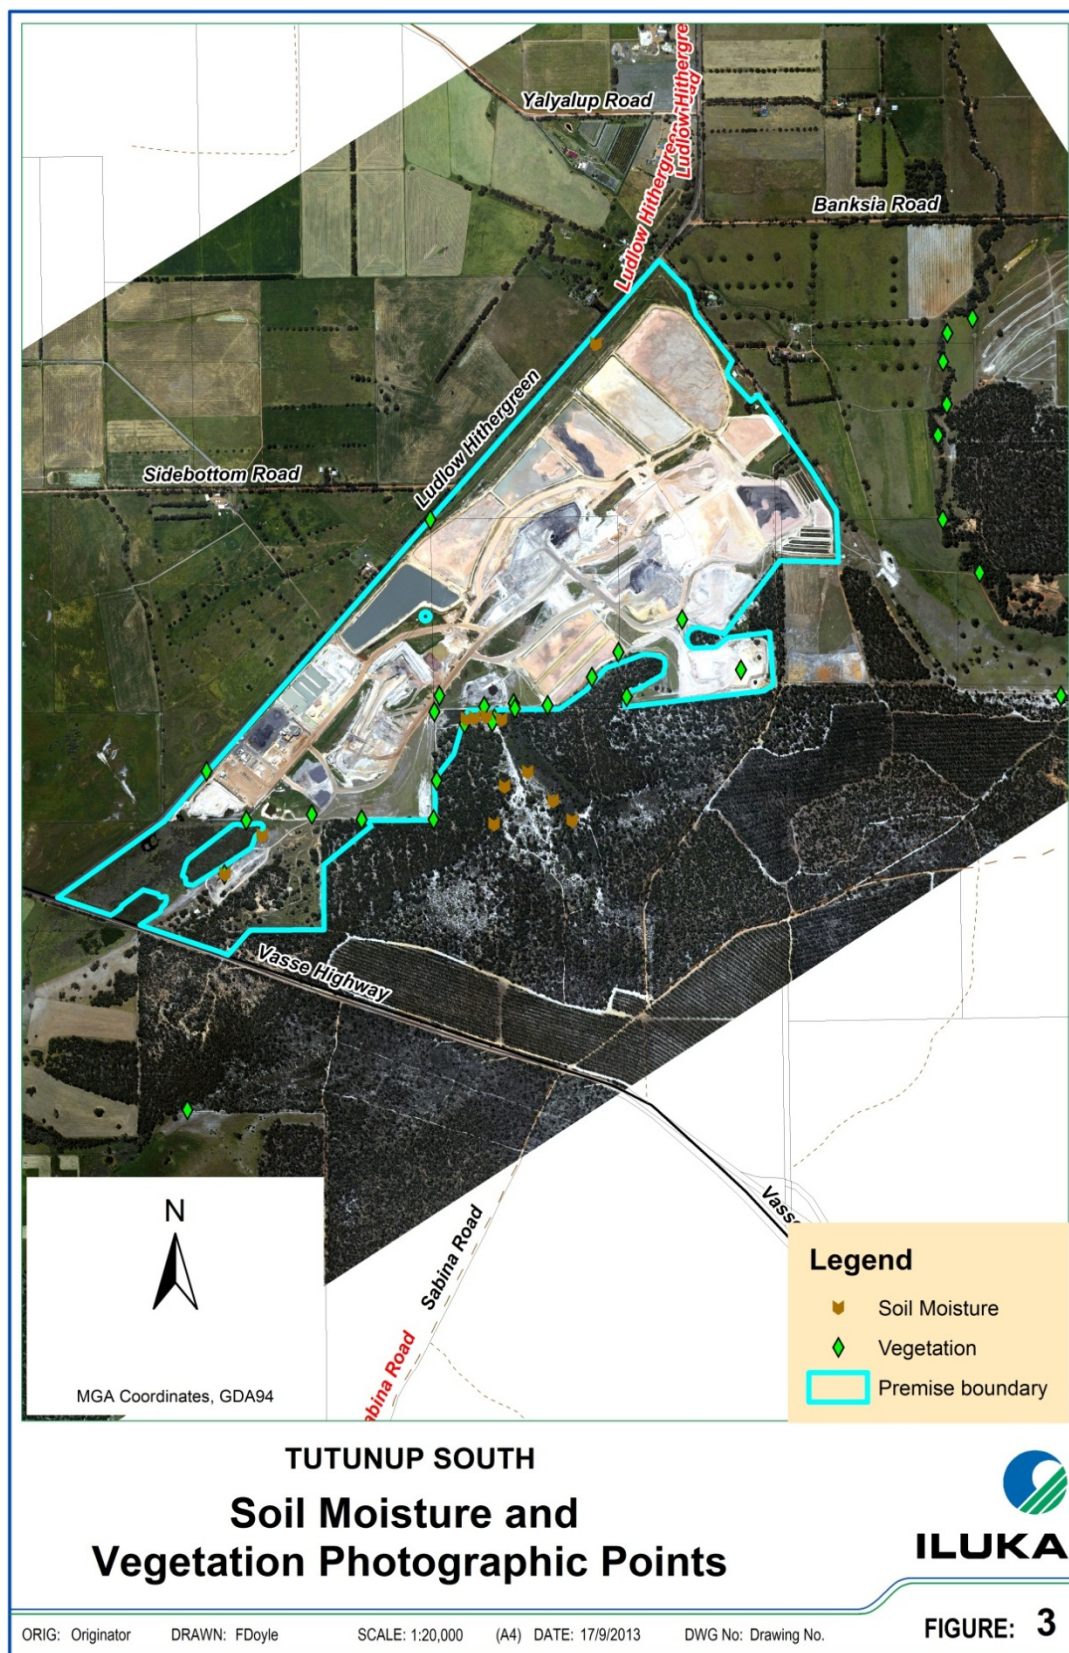
Figure 3. Location of Soil Moisture Tubes and Vegetation Photographic points.

The locations of the vegetation photographic points and the soil moisture tubes are shown in Figure 3.

Iluka photographic points recorded an impact at one site with a number of a number of shrubs and small trees dying.

To improve environmental management in this location, supplemental water was applied via a water truck to the edges of the area throughout summer to mitigate the impact. This resulted in the reshooting of plants. This mitigation measure is intended to continue from the spring season.

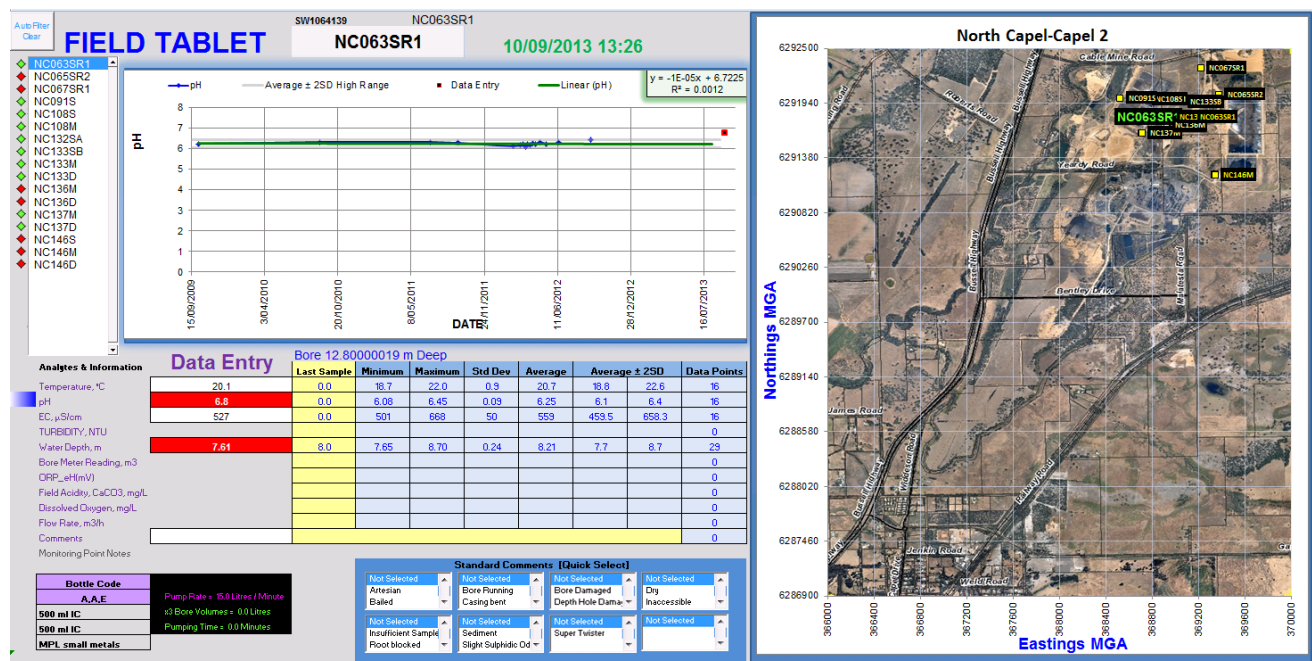
Figure 4. Field Tablet software, piezometer.

To improve the field data collection process, software has been developed internally for application on a field tablet. Previously, written work sheets were taken into the field and the information was transcribed to a database upon returning to the office. The Environmental Technicians use the field tablet as a tool to log and review information about the monitoring point in the field. The configuration of the Standard Comments or the calculation box varies depending whether a piezometer (Figure 4), surface sample (Figure 5) or alternate sample type is selected.

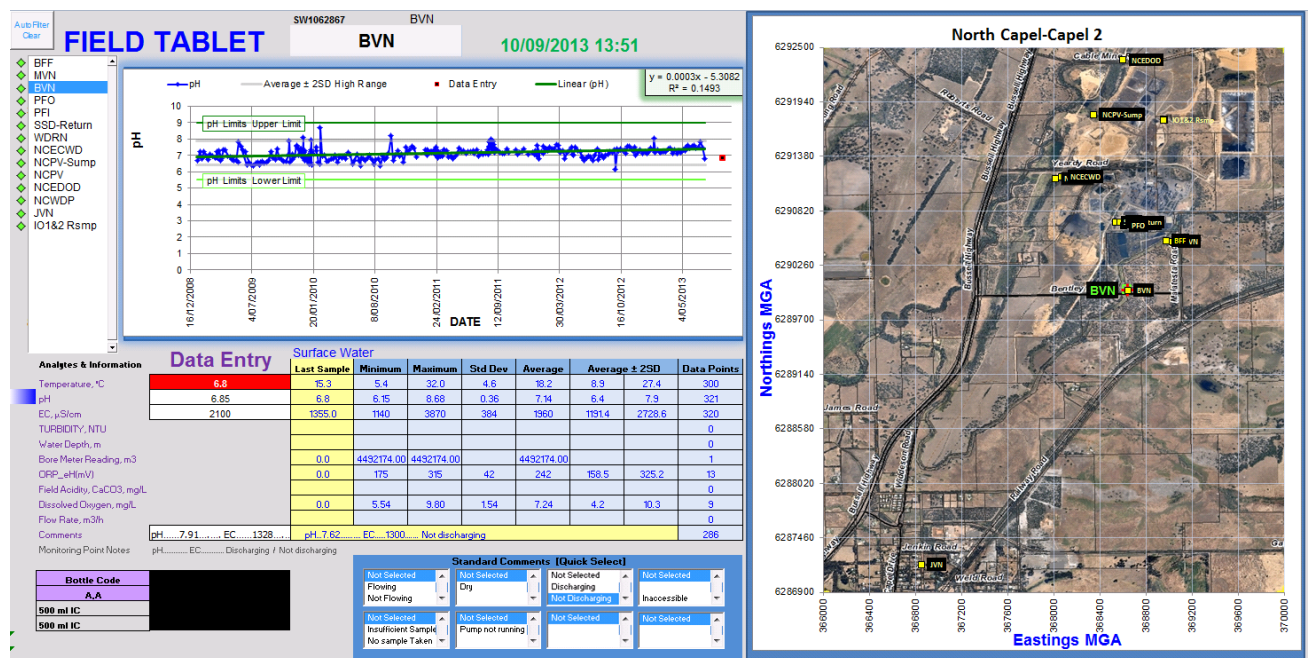
Figure 5. Field Tablet software, surface sample.

- A chart of historical monitoring results, showing error bars, as well as any required compliance limits.
- Statistic tables for the results, as well as the results and comments when last sampled.
- Conditional formatting and message boxes draw attention to outlying new values.
- The location of the site is highlighted on a map [Useful for novice technicians].
- A table of required sample bottles.
- Calculating pumping times to achieved prescribed bore volumes.
- Providing standard field comments which can be selected allowing better data filtering capabilities and automating compliance checks.

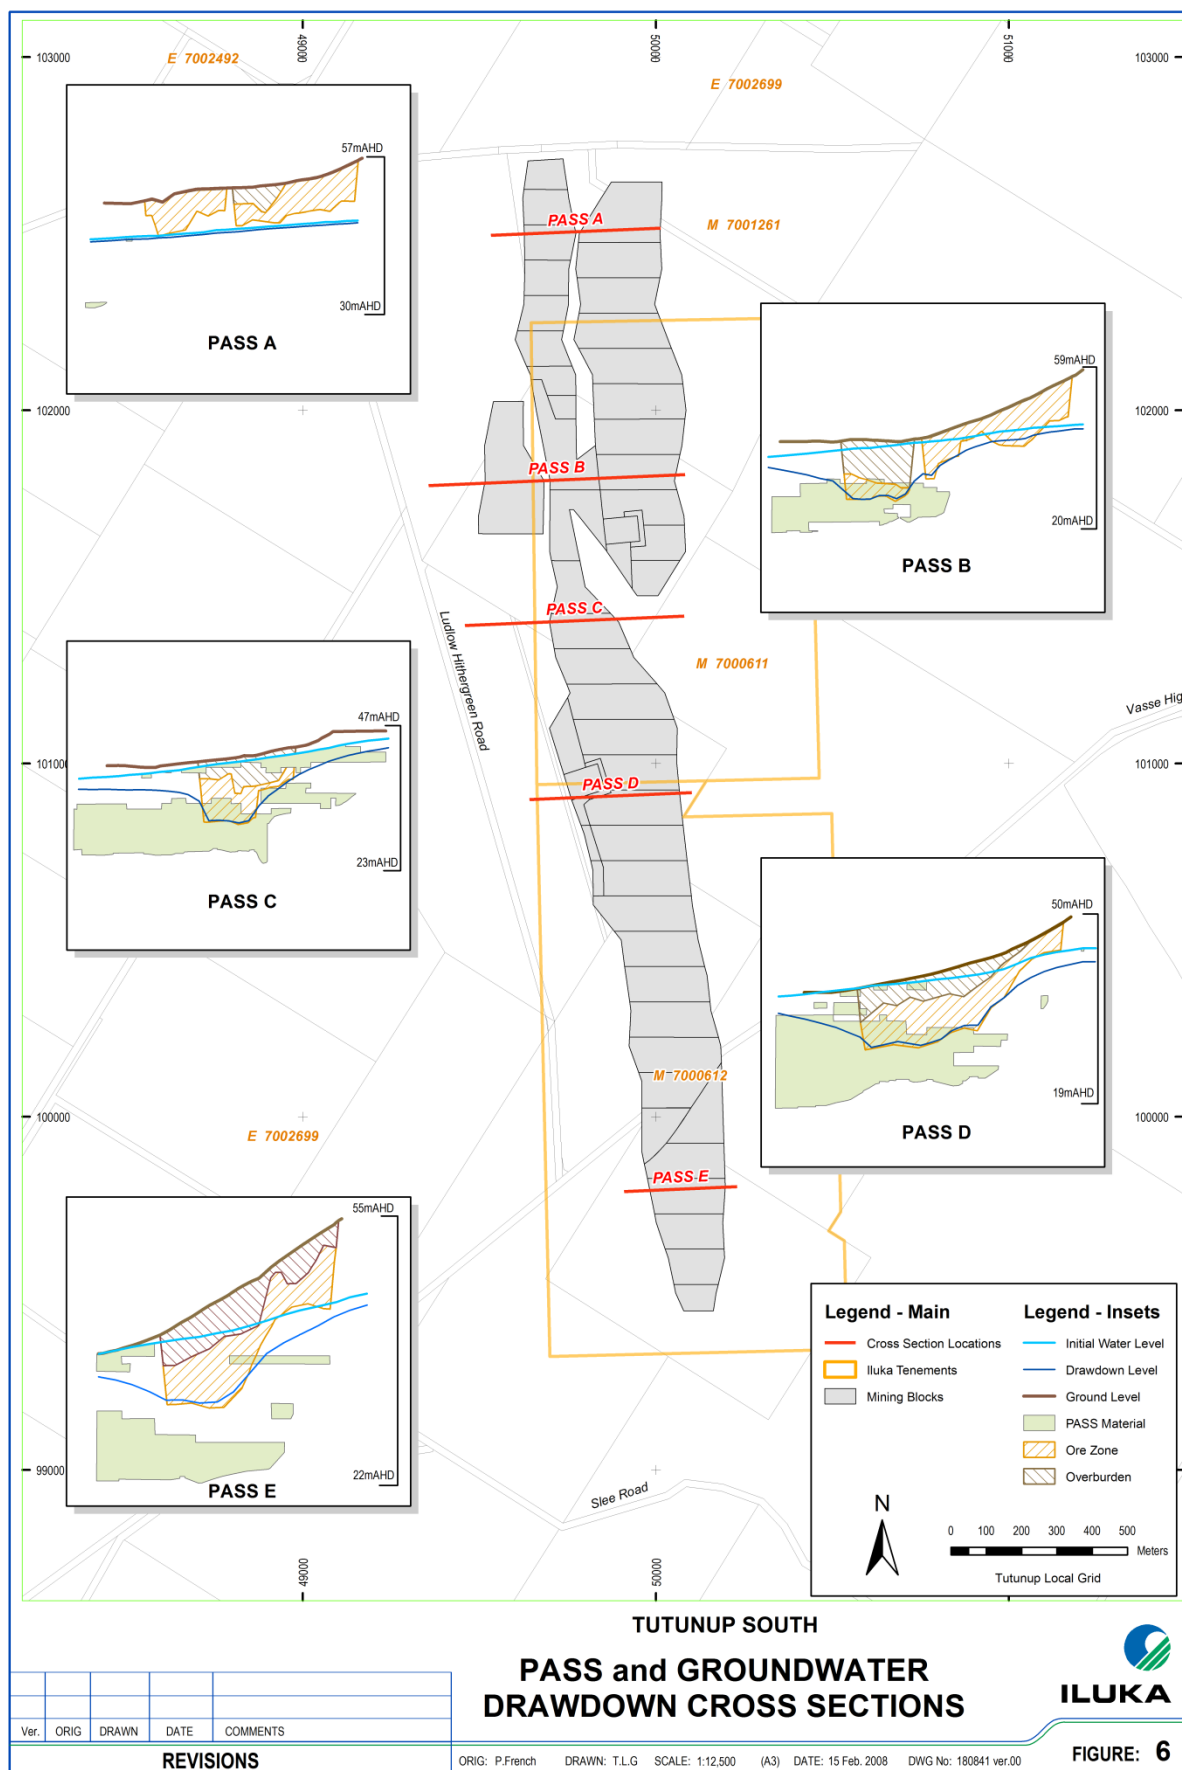
Figure 6. PASS and Groundwater Drawdown Sections.

To achieve this objective Iluka developed an Acid Sulphate Soil Management Plan (ASSMP) using government guidelines and onsite scientific assessments of the project area. A model of the project area was created using drilling results to give a prediction of the location of the PASS material. The ASSMP has since been peer reviewed in 2008 (Sullivan, L. 2008) and 2010 (RPS). A further independent review of the ASSMP has been commissioned for 2013 (RPS).

Iluka has a staff member and associated resources dedicated to the implementation of the ASSMP at Tutunup South Mine. An onsite soil testing facility has been made available to ensure rapid testing and recommendations can be made to the operations in a timely manner. To date 2700 samples have been analysed in accordance with the ASSMP and reported in the AER. Figure 5 shows a simplified version of the block model used to guide daily mining operations, which details location of PASS, overburden and the ore body.

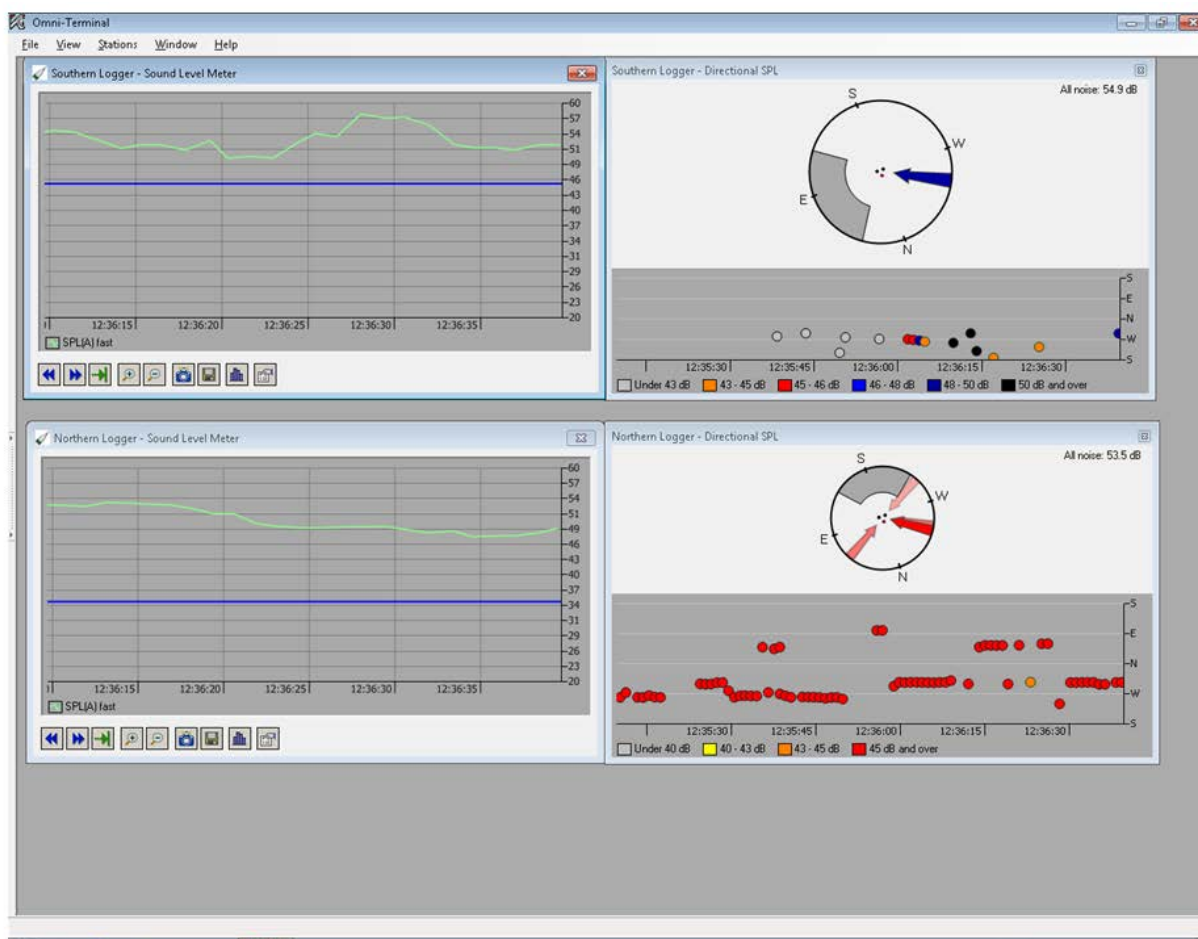
Figure 7. A screenshot of the active live noise monitoring system for Tutunup South Mine.

To improve on this environmental management technique, Iluka installed an active live noise monitoring system that is available continuously to site controllers and operators. The main system components are directional sound level meters (DSLMS) and wireless network communications. This provides live feed to the control room and operators can determine the noise level and direction of the noise source at any given point in time. The system has been available for more than 95% of the time the plant has been operating.

Should the noise level approach the limits prescribed in the *Environmental Protection (Noise) Regulations 1996*, then the site controllers can take action to reduce it. The system allows the operator to listen to the sound the DSLM is measuring by remote and therefore determine if the noise is due to mining activity or not. Should the noise be from the operations, then a series of actions are taken including: moving machinery; shutting down ancillary plant; and ultimately shutting down all activity.

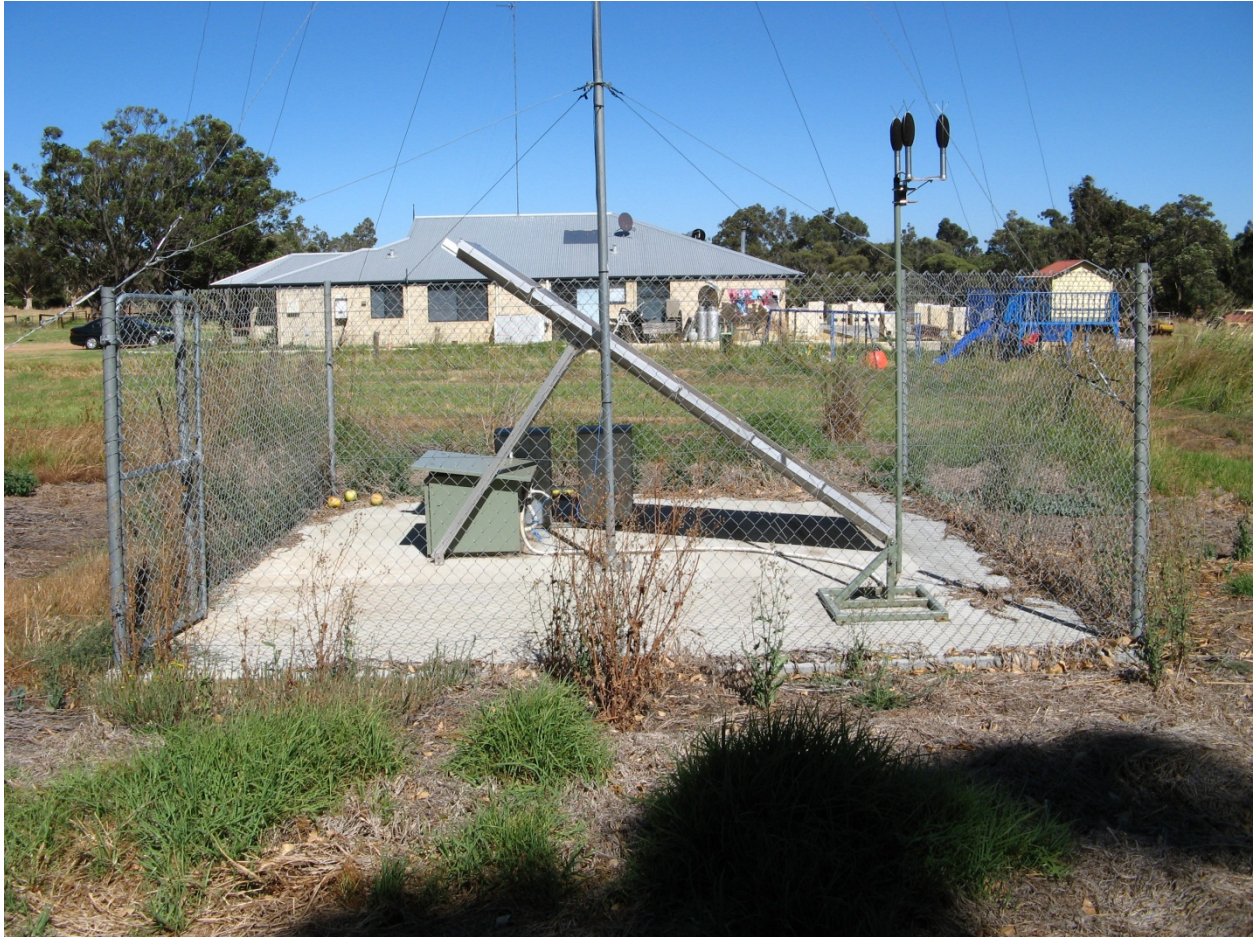
Figure 8. Example of the directional sound level meters (DSLM) used at Tutunup South Mine.

Records of any self-managed shutdown actions are kept by the operators. There has only been one public complaint relating to mining activity noise at Tutunup South since its inception. The investigation into the incident indicated that the site was likely to have been compliant with the regulations but still audible to the resident.

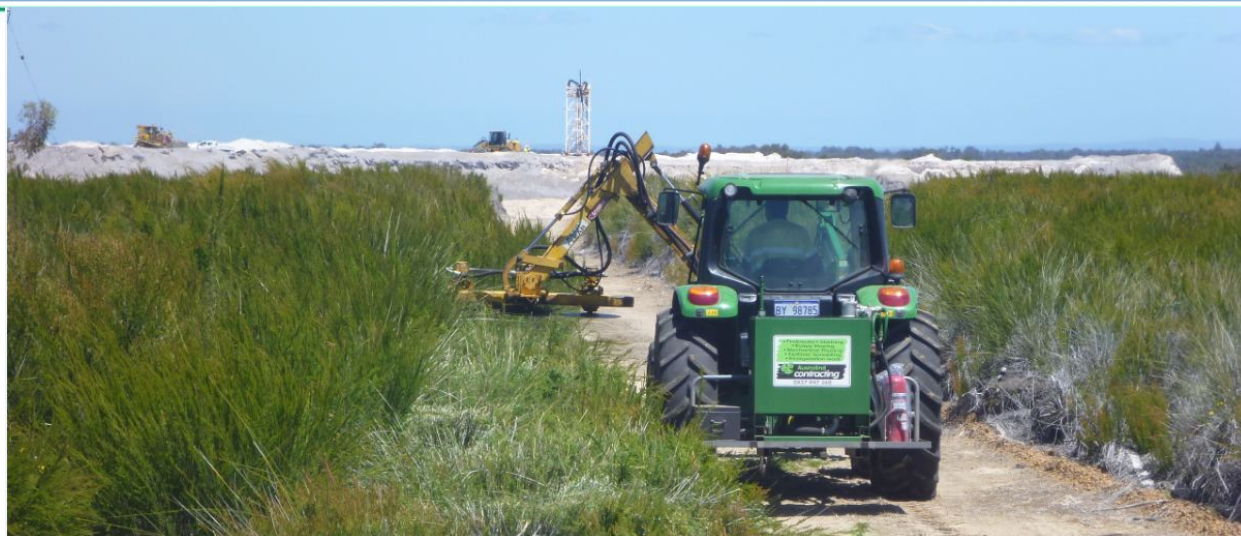
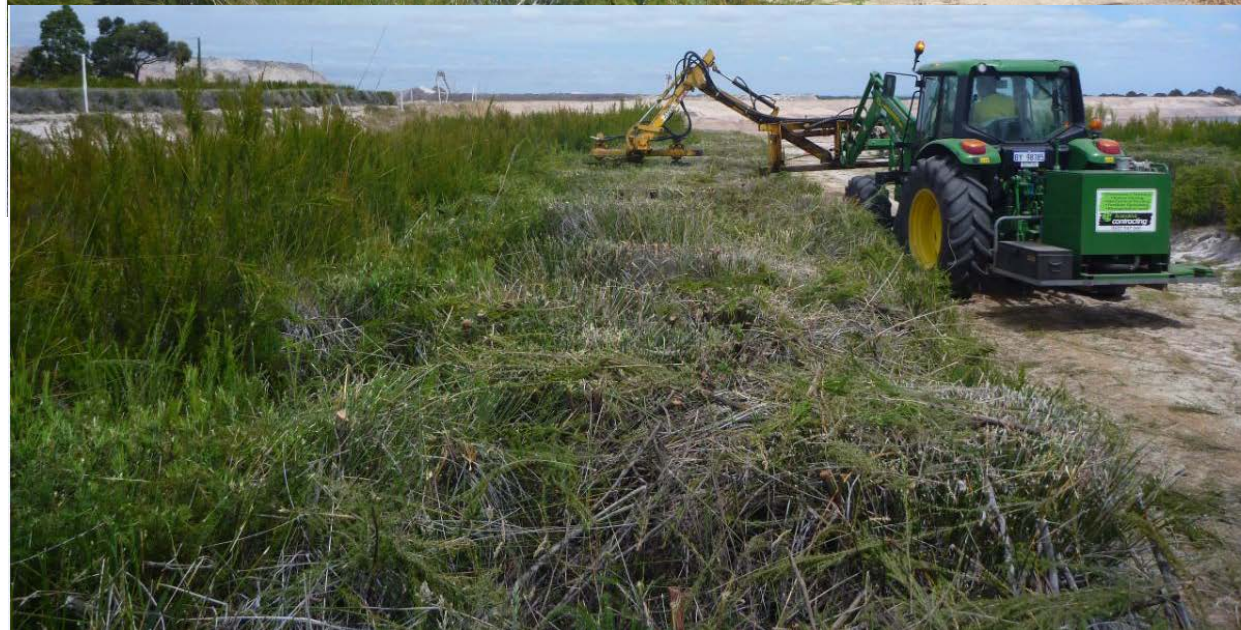
# Translocation Progress After 26 months: December 2012

**Mechanical Pruning to reduce transpiration and stress on watering system**

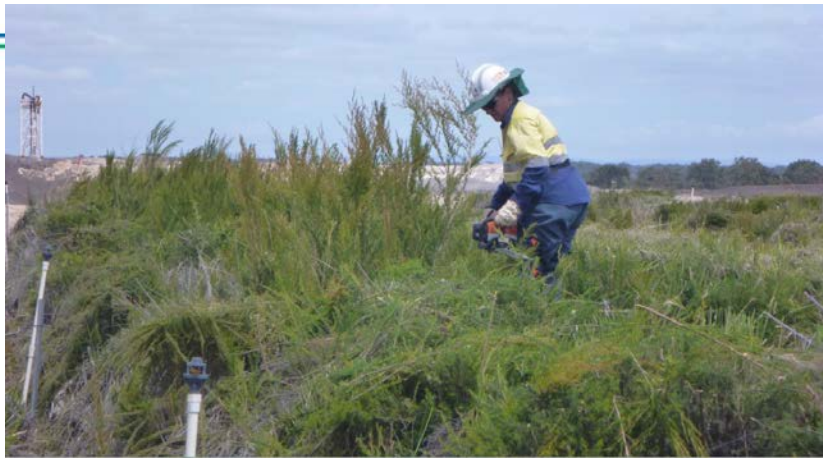
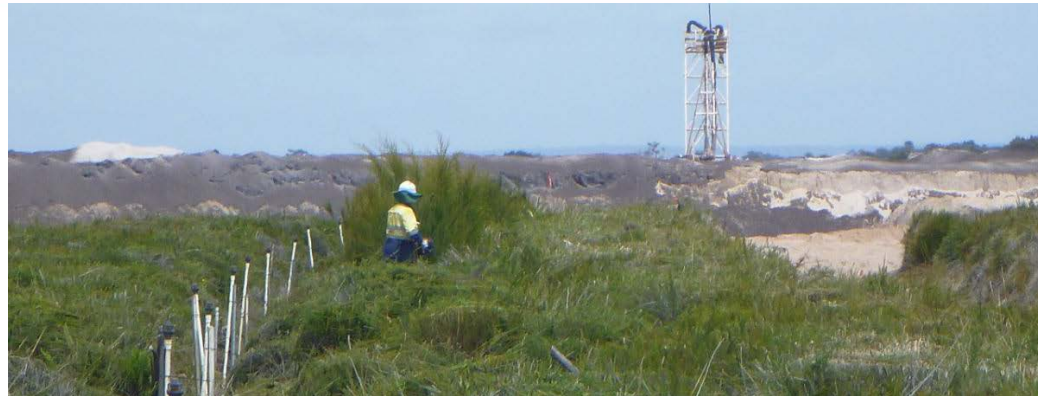
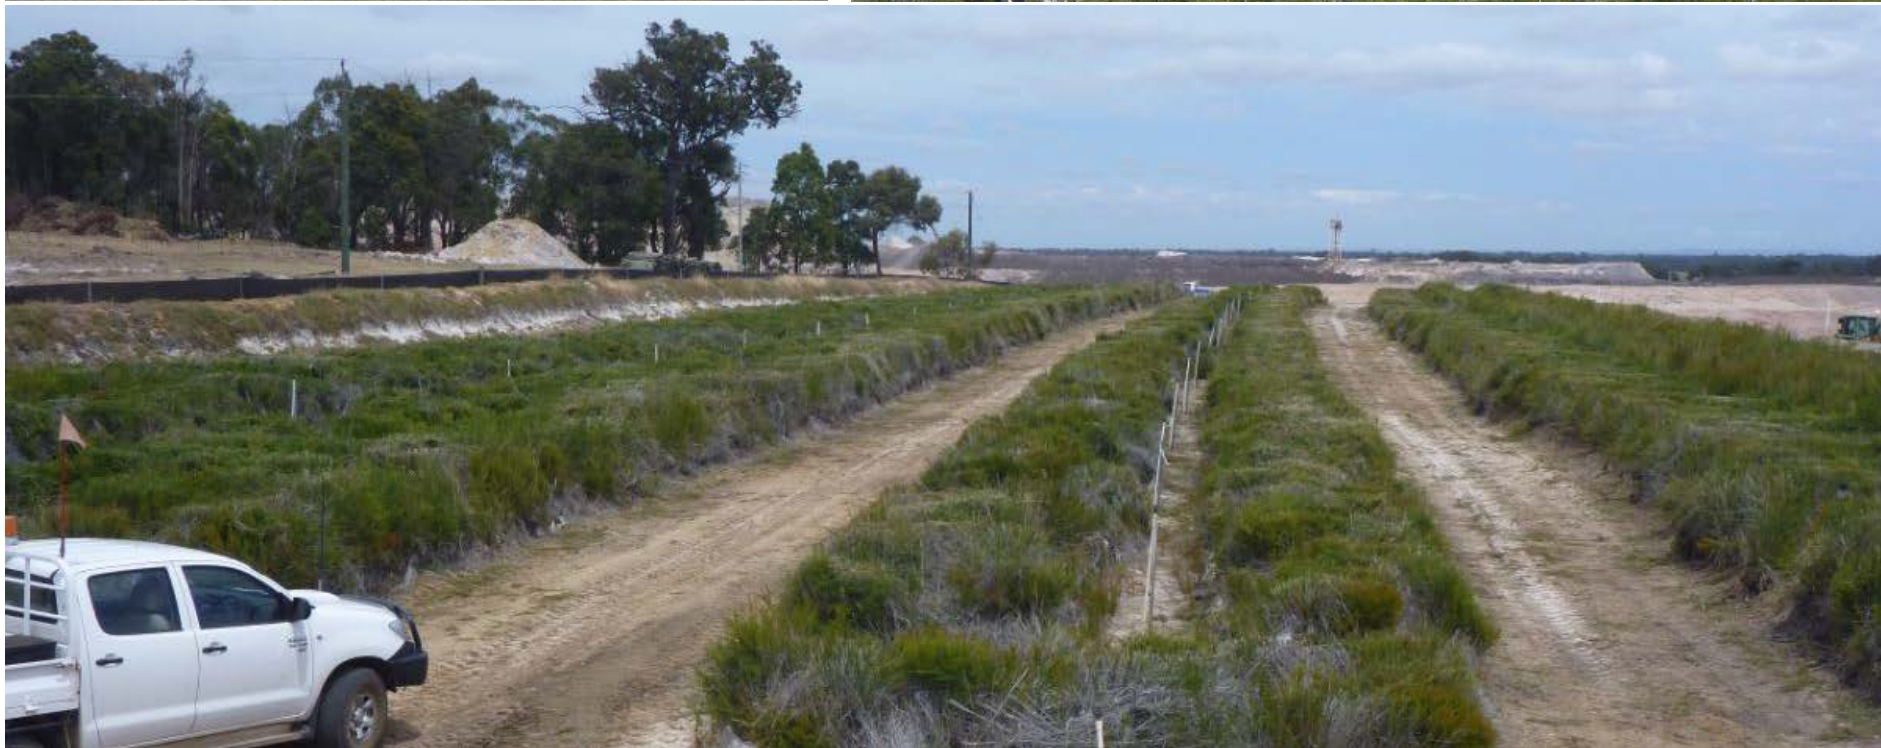
# Translocation Progress After 26 months: December 2012

**Mechanical Pruning to reduce transpiration and stress on watering system**

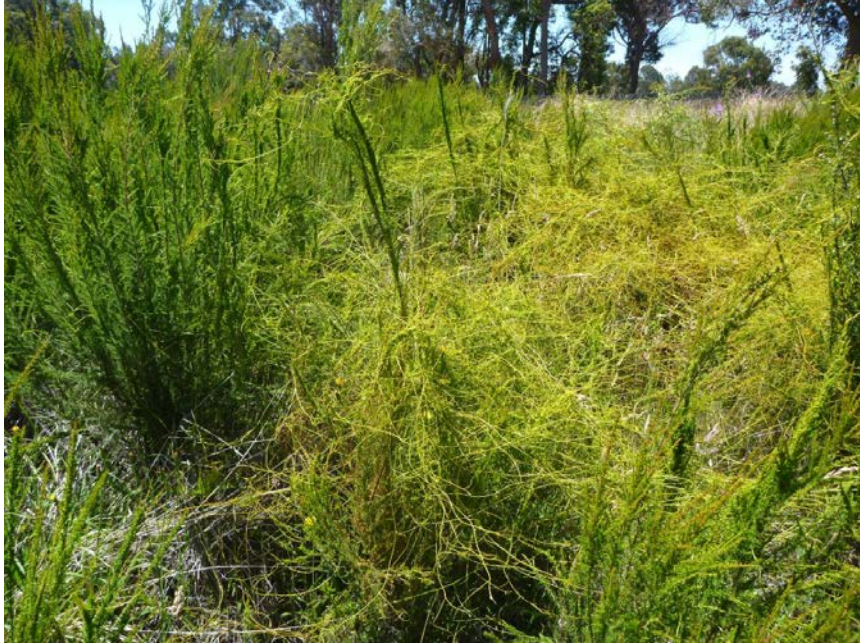
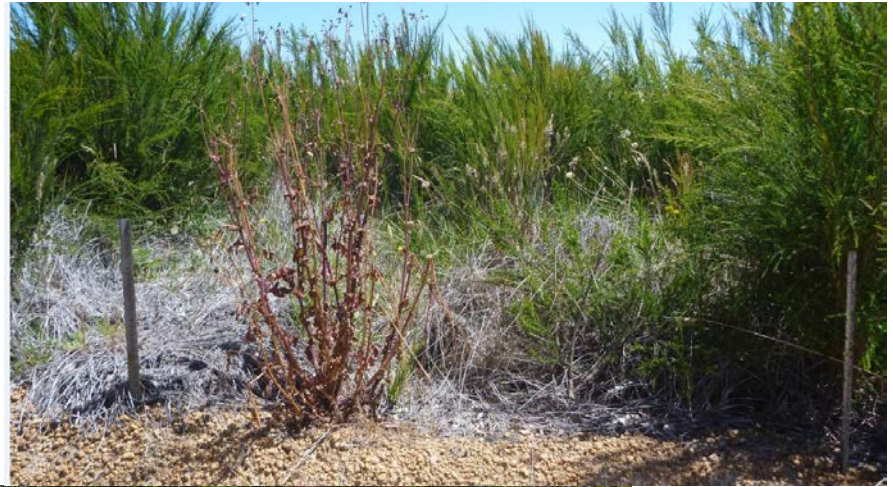
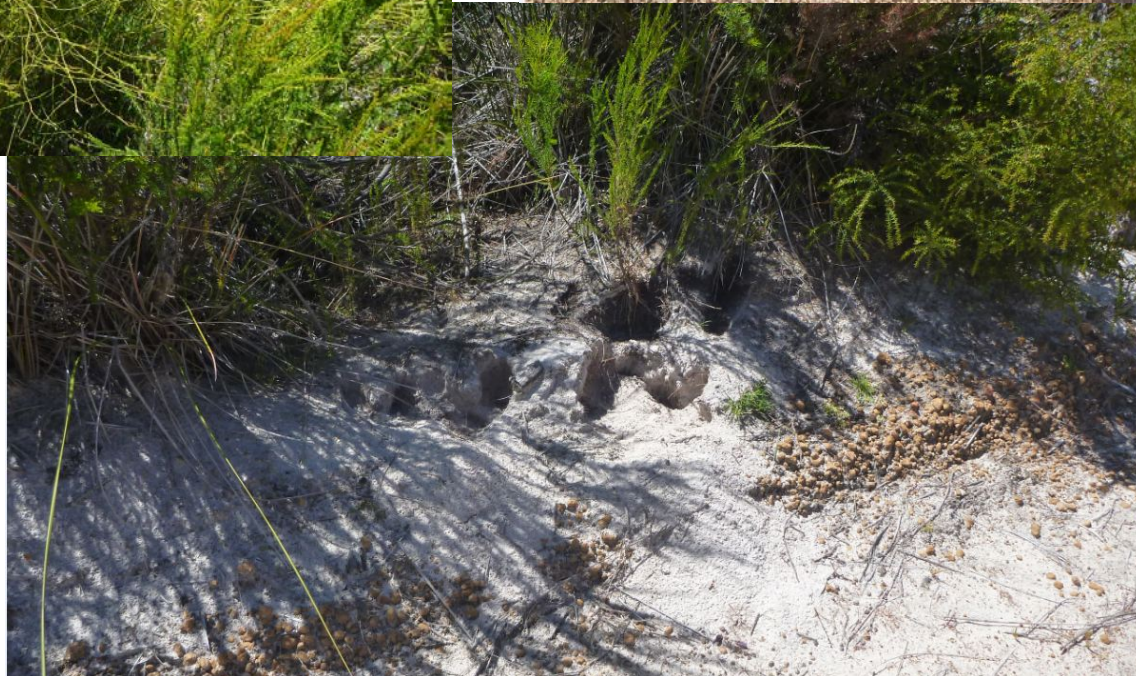
# Translocation Progress After 26 months: December 2012

**Management issues going forward:**

**Watering, Yearly pruning , weeds, rabbits and Dodder invasion**
