Iluka Resources Limited  
South Capel Remediation Project  
EPBC 2018/8250  
Annual Compliance Report  
23 September 2024 – 22 September 2025  
Document Number: PUW2EJ62XMPT-1245019849-235282

The South Capel Remediation Project (SCRP) being undertaken by Iluka Resources Ltd (Iluka) is remediating point sources of groundwater contamination associated with historic by-product storage at both the South Capel facility (Figure 1) and the Capel Dry Plant (Figure 2). In July 2018, Iluka referred the SCRP to the Department of Agriculture, Water and the Environment (the Department) under the *Environmental Protection and Biodiversity Conservation Act 1999*. In October 2018, Iluka received formal notification that the SCRP was a controlled action likely to have significant impact on Matters of National Environmental Significance including listed flora species and the Western Ringtail Possum (WRP) (*Pseudocheirus occidentalis*). On the 19 September 2019 approval was granted for the controlled action (EPBC 2018/8250) as per details in Section 1.1.

Revegetation earthworks commenced in 2020 and native vegetation establishment was completed in July 2021. As per the requirement of the SCRPs RMP

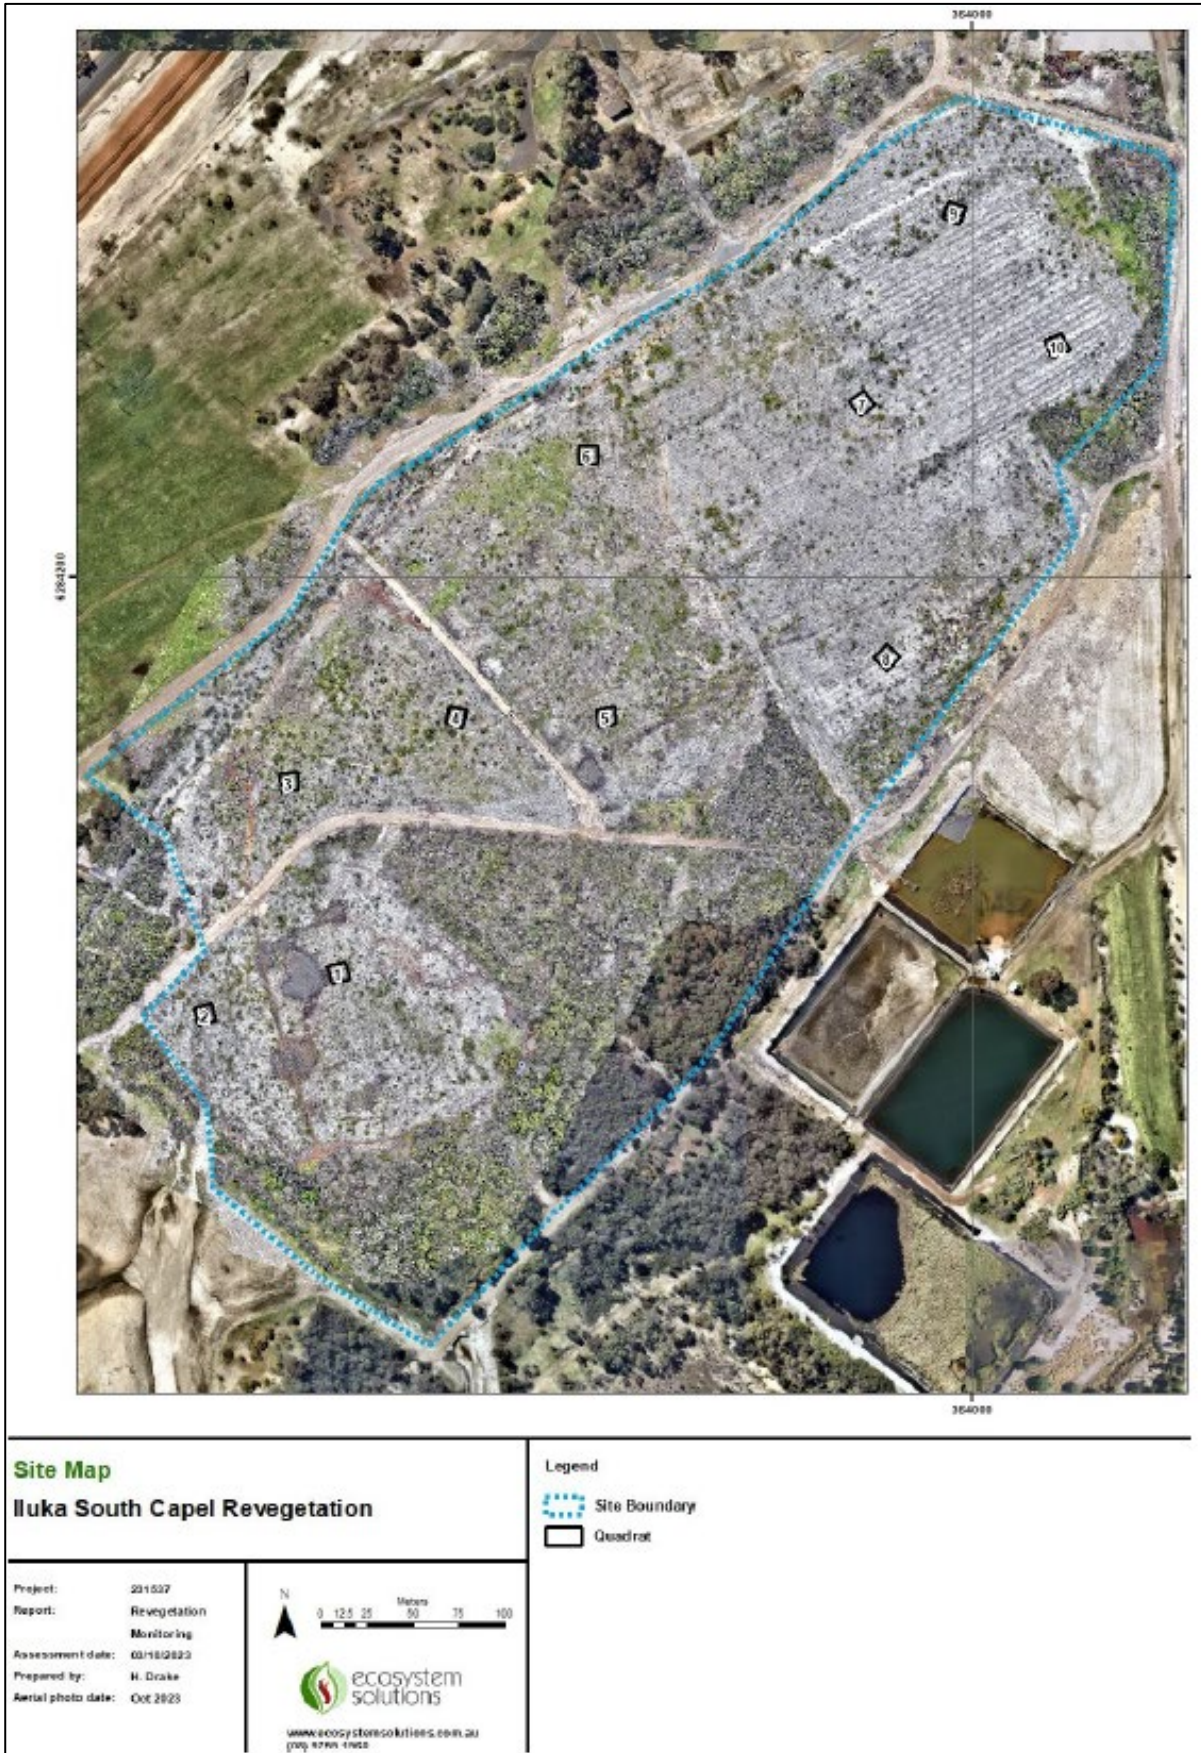
Figure 3: Monitoring Quadrat Locations

Ten 10 m × 10 m quadrats were established in the Year 1 site survey at the locations provided by RPS, using a global positioning system (GPS). RPS chose sites for quadrat placement based on existing soil mapping and previous land use, to capture site variability potentially leading to differences in plant establishment. Consideration was also given to locating quadrats in areas where traversing vegetation works was minimised so as to prevent incidental damage. Each quadrat was marked with a labelled metal fence dropper at each corner. A GPS waypoint was taken at each dropper, allowing for reestablishment of quadrats in future years if required.

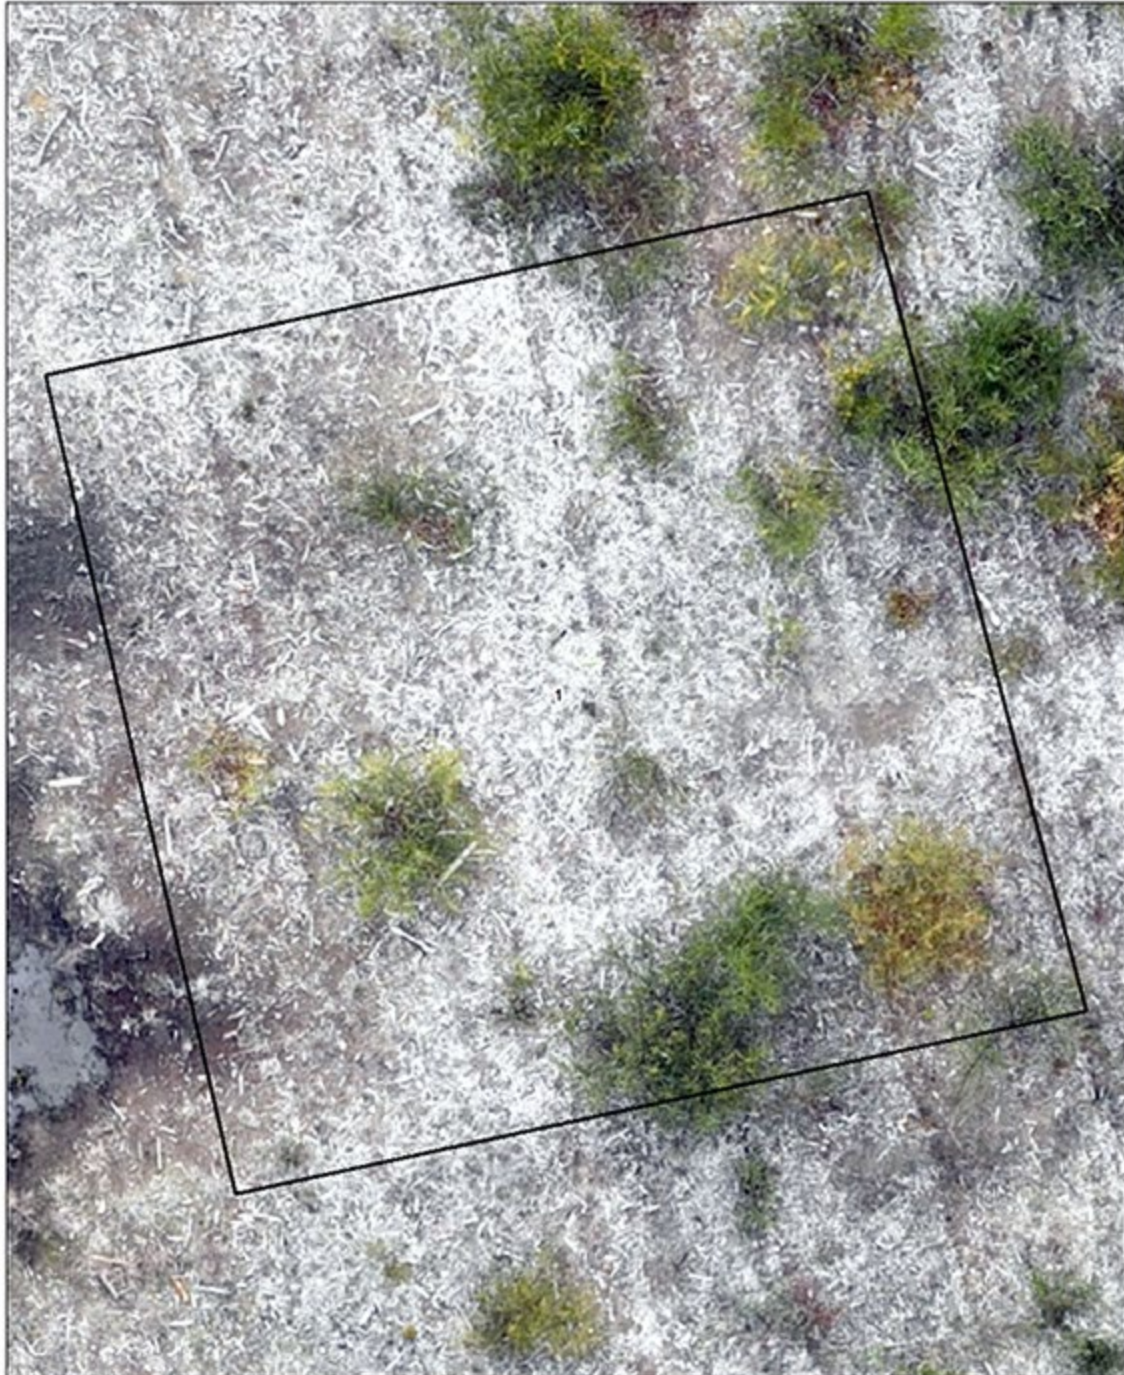
### Quadrat 1 Iluka South Capel Revegetation

Project: 201537  
Report: Revegetation  
Monitoring  
Assessment date: 06/10/2023  
Prepared by: H. Drake  
Aerial photo date: Oct 2023

Note: Map includes drone image overlay taken 3 October 2023 (2cm/pixel)

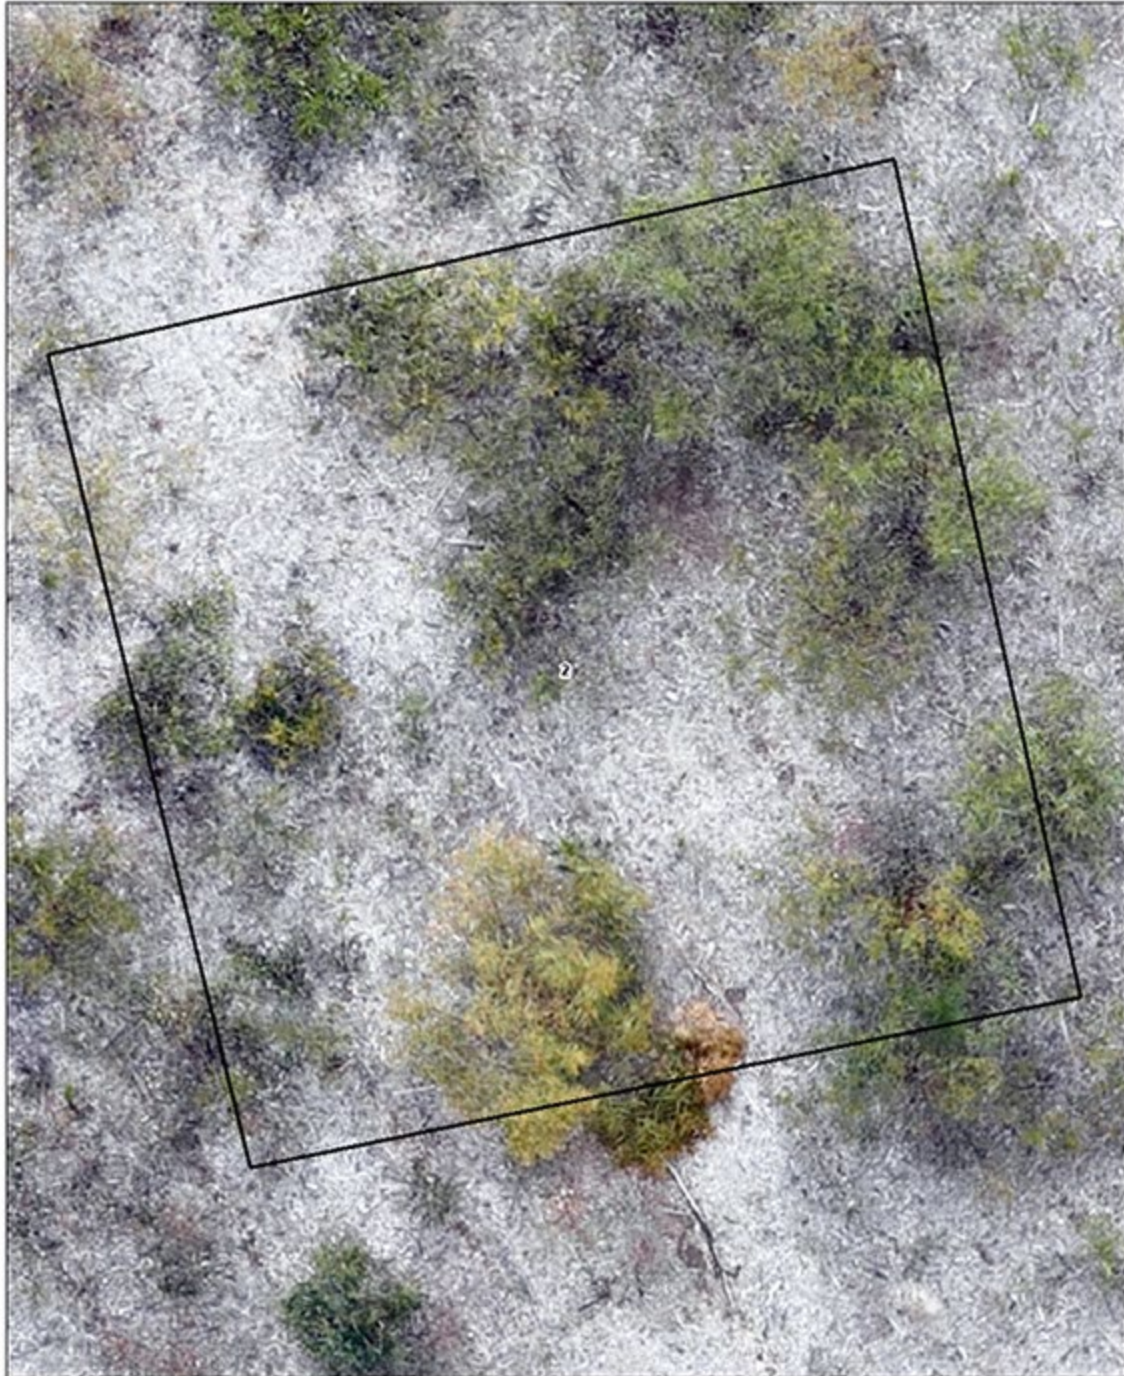
**Quadrat 2**  
**Iluka South Capel Revegetation**

Note: Map includes drone image overlay taken 3 October 2023 (2cm/pixel)

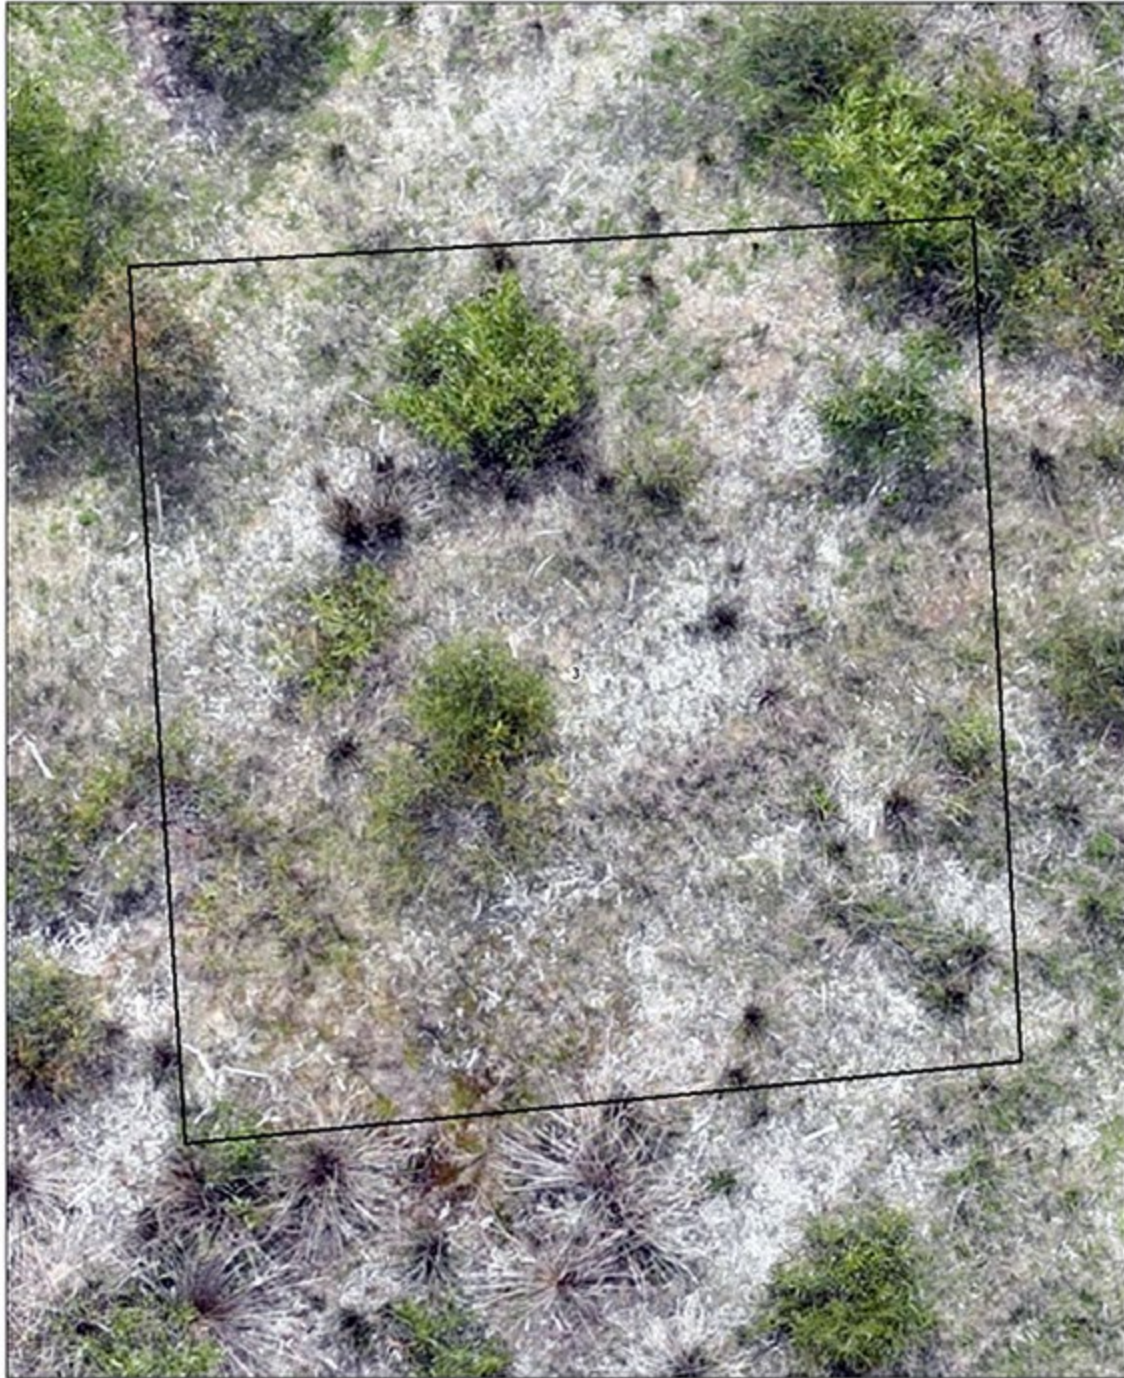
**Quadrat 3**  
**Iluka South Capel Revegetation**

Note: Map includes drone image overlay taken 3 October 2023 (2cm/pixel)

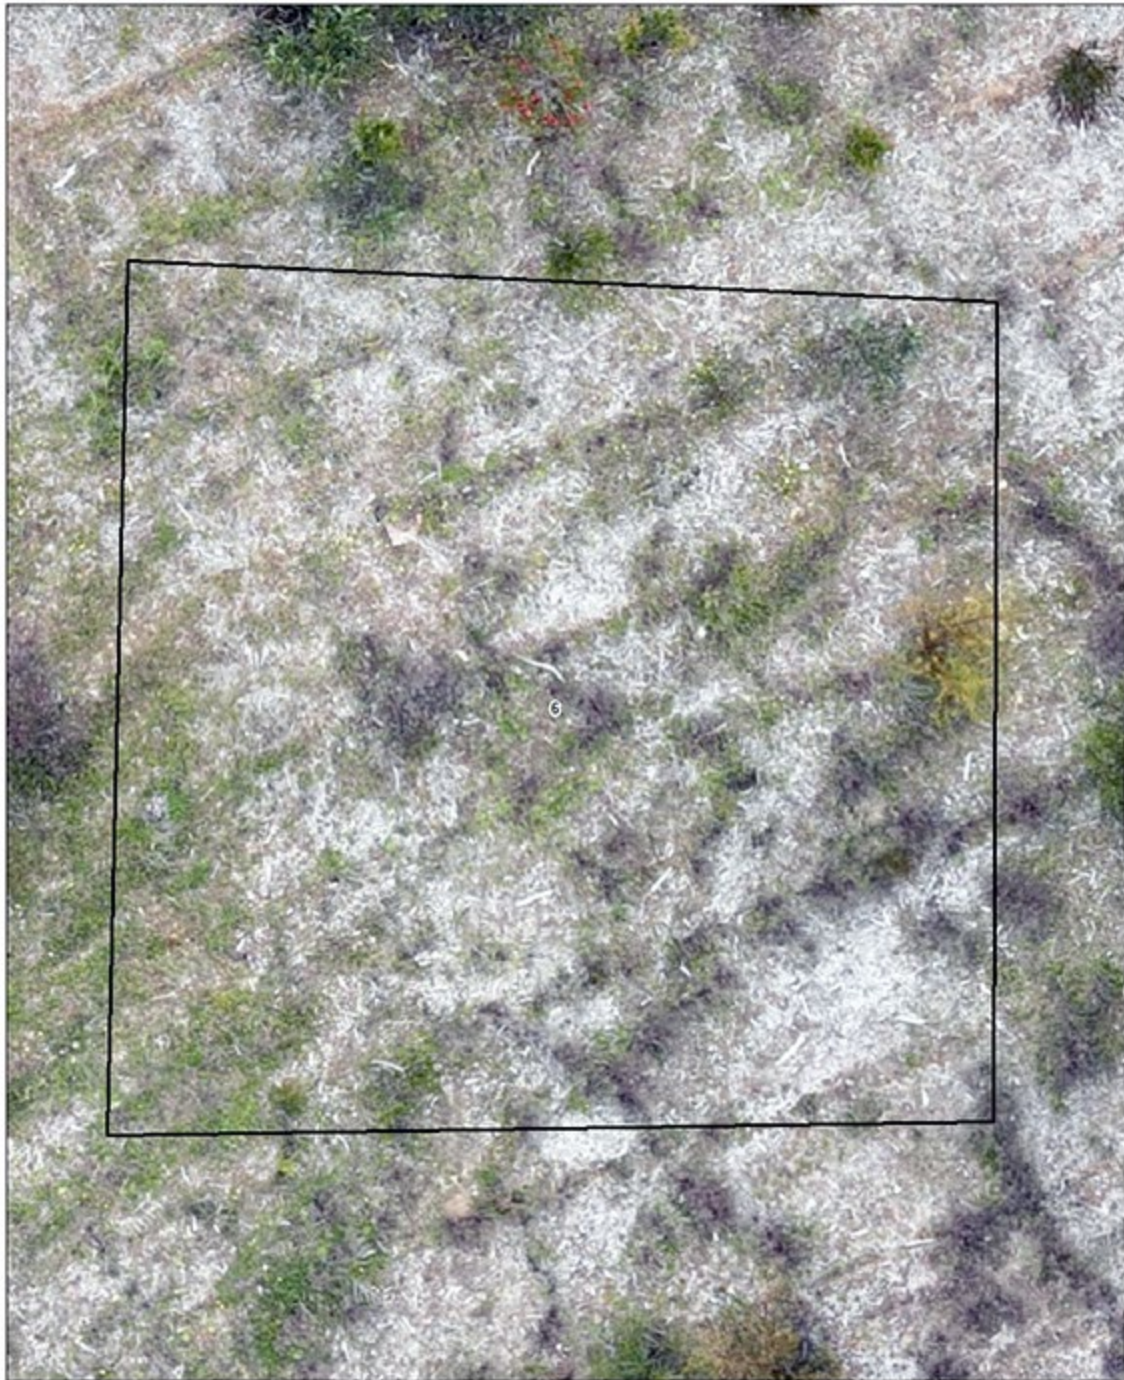
**Quadrat 6**  
**Iluka South Capel Revegetation**

Note: Map includes drone image overlay taken 3 October 2023 (2cm/pixel)

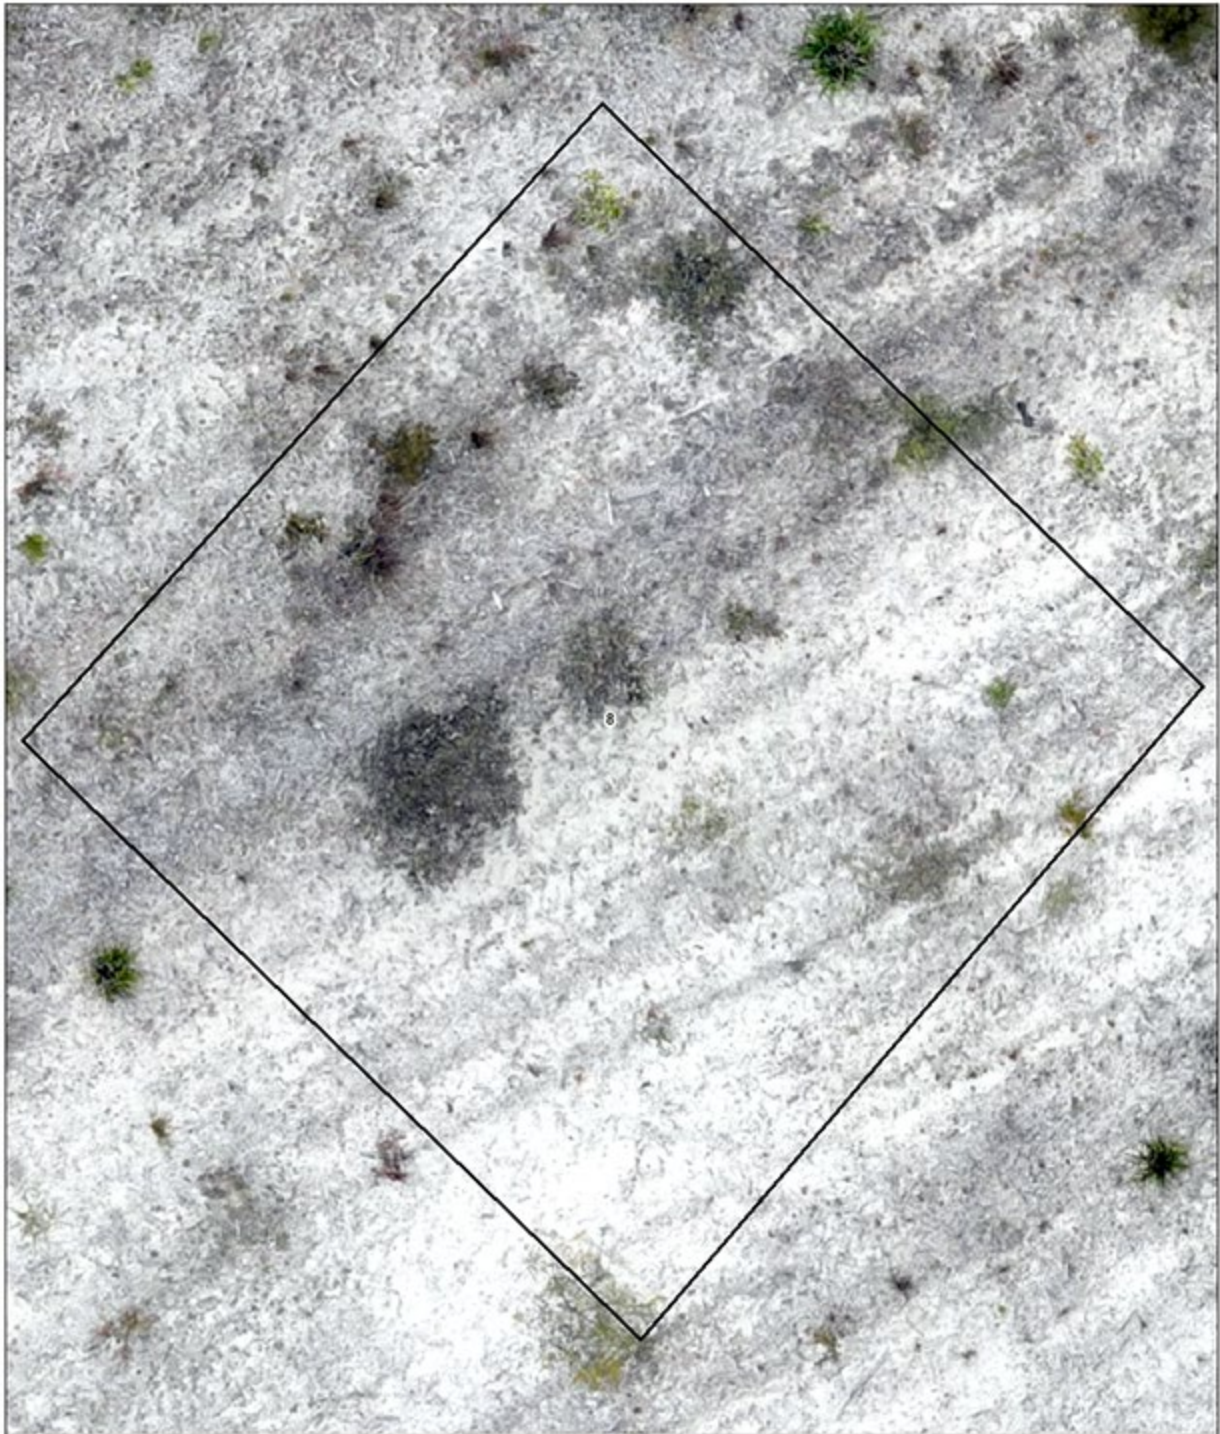
**Quadrat 8**  
**Iluka South Capel Revegetation**

Note: Map includes drone image overlay taken 3 October 2023 (2cm/pixel)

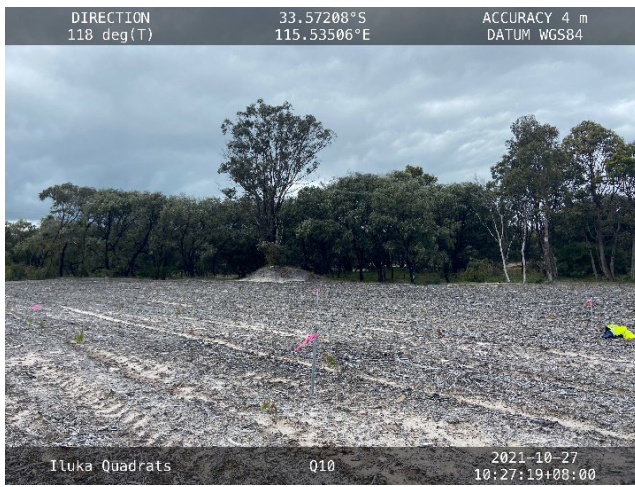
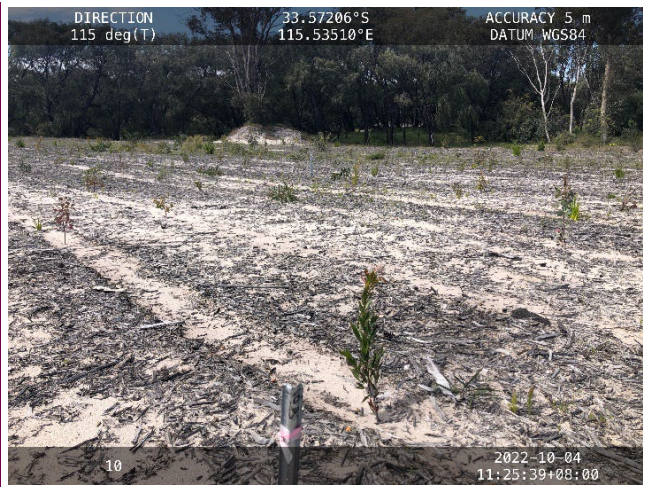
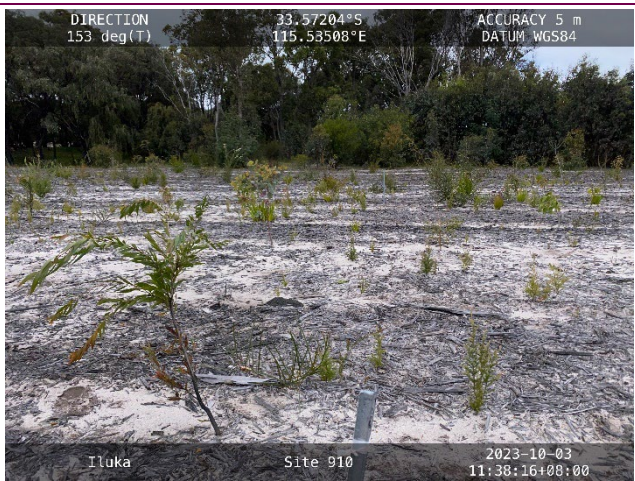
# Quadrat 10

Species richness	Stem density	Canopy cover	Weed cover (%)	Bare earth (%)
14 species	210 stems/100m <sup>2</sup>	20%	1%	40%
Species	Number	Canopy value	Forage value	Ground protection value
<i>Acacia saligna</i>	11	✓	✓	✓
<i>Agonis flexuosa</i>	2	✓	✓	
<i>Allocasuarina fraseriana</i>	34	✓	✓	
<i>Anigozanthos flavidus</i>	9			✓
<i>Calothamnus quadrifidus</i>	12			✓
<i>Corymbia calophylla</i>	3	✓	✓	
<i>Eucalyptus rudis</i>	3	✓	✓	
<i>Hardenbergia comptoniana</i>	1		✓	✓
<i>Kunzea glabrescens</i>	127	✓	✓	✓
<i>Acacia cyclops</i>	1	✓	✓	✓
<i>Leptomeria cunninghamii</i>	4			✓
<i>Billardiera fusiformis</i>	1			✓
<i>Jacksonia</i> sp.	1			✓
<i>Banksia</i> sp.	1	?	?	✓
<b>Number of species</b>		7	8	10
<b>Number of stems</b>		181	182	168
<b>Number of stems/hectare</b>		18,100	18,200	16,800
<b>Weed species</b>		<b>Mulch cover</b>	<b>Erosion</b>	
8		50%	No change
